Following the full survey and documentation of all existing conditions at Building 18 in Magnusen Park for the new Outdoors For All facility, I have prepared the following report. There are two main window types/vintages present. The ground floor and a couple of the second-floor windows are of an older and more traditional style of steel window with the predominant windows at the second level appearing to be newer and in not as good condition.

Outdoors for All Window Remediation Summary and Recommendations

BUILDING 18 WINDOW SURVEY

**Rafn- BLDG#18
WINDOW SURVEY**

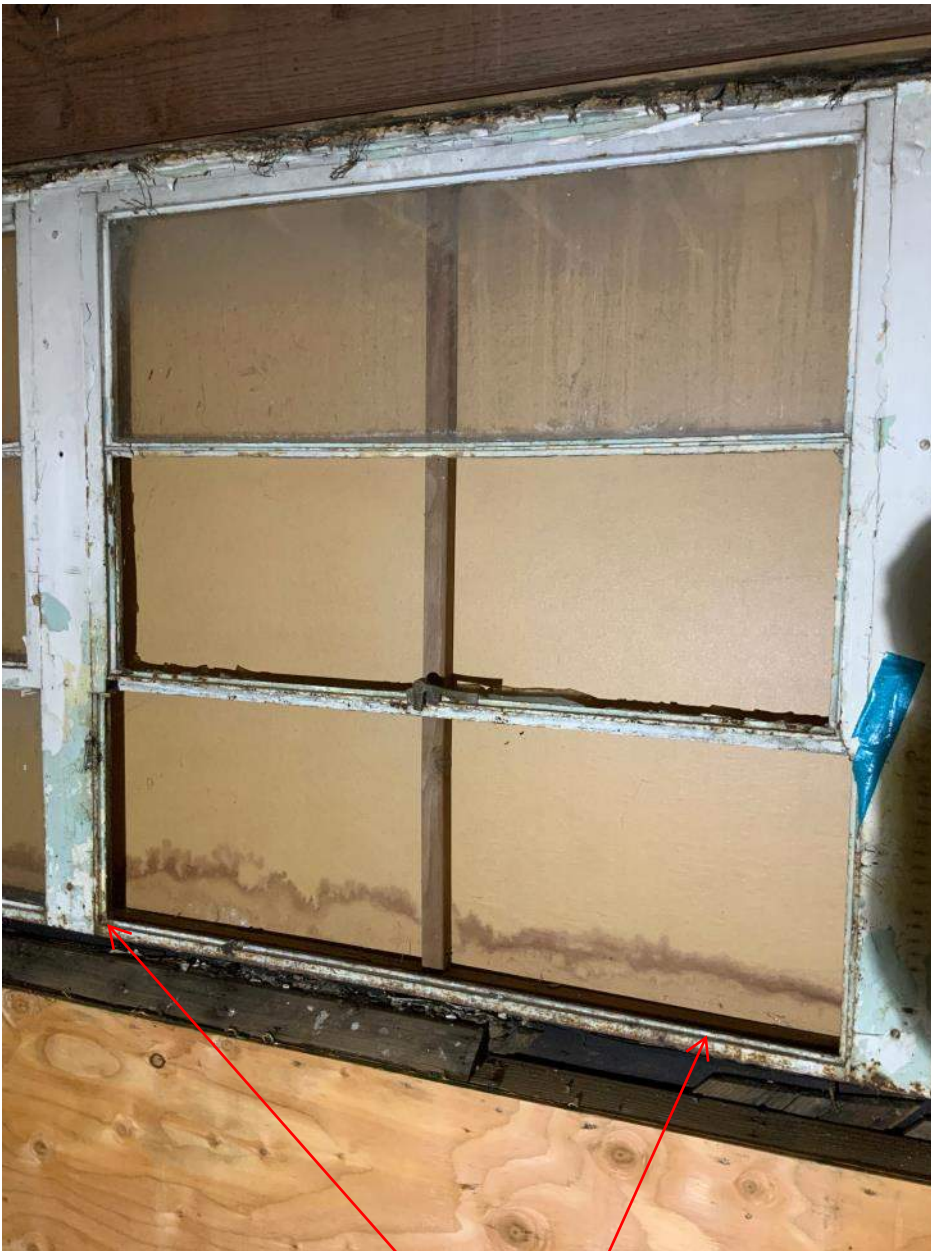
Surface Rust and Pitting Beginning on Bottom Rail and Mullion

Surface Rust and
Pitting

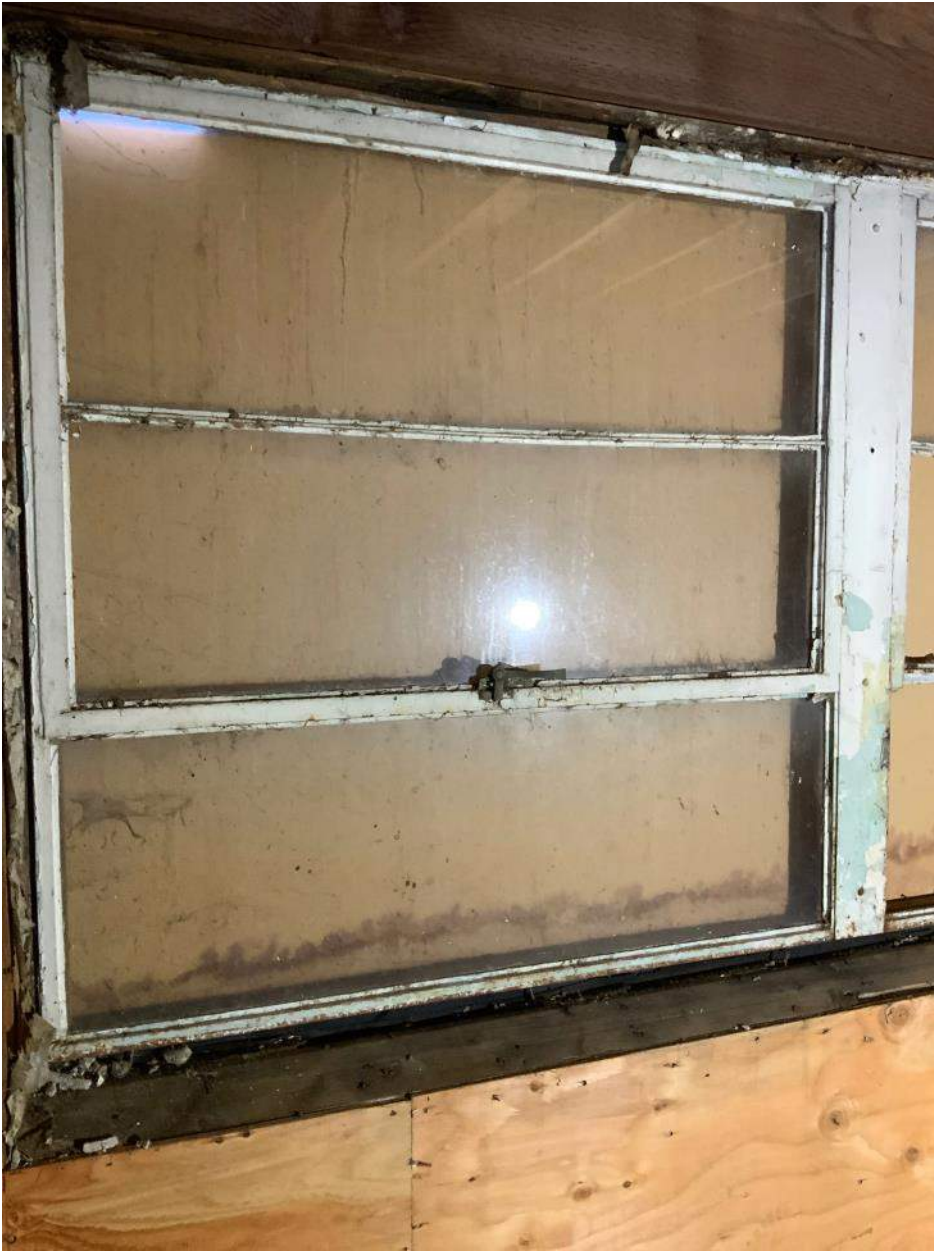
Surface Rust and Pitting Beginning on Bottom Rail and Mullion
